First Five-Year Review Report

Helena Chemical Co. Landfill City of Fairfax, Allendale County, South Carolina

United States Army Corps of Engineers, Charleston District Charleston, South Carolina

April 2004

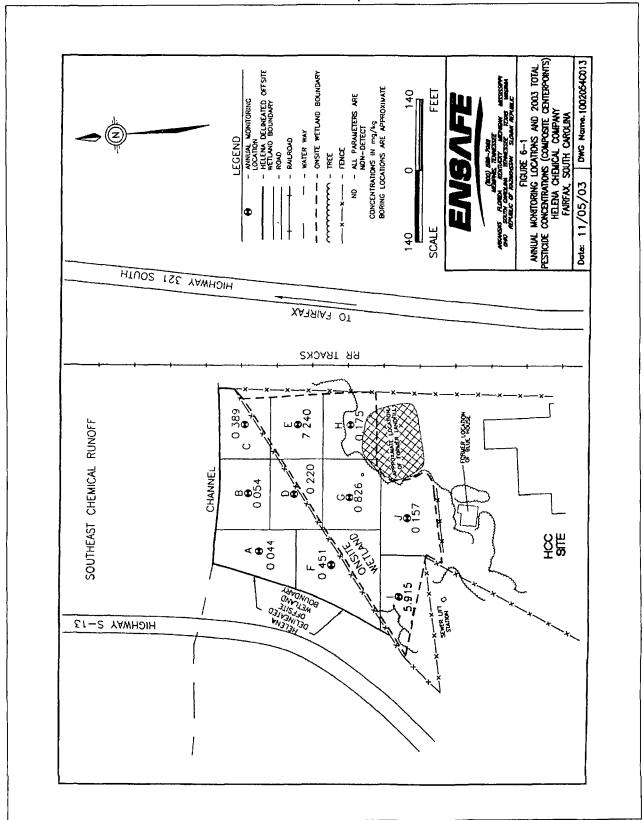
Attachment 9. Sediment Sample Grid Locations

Pesticide concentrations found in sediment within the wetland area have been monitored in accordance with the Remedial Action work Plan Samples are collected annually from 10 locations as indicated in Attachment 9. Prior to the 2003 annual monitoring, all sample locations had exhibited total pesticide concentrations below the RAO of 5 mg/kg. The August 2003 Grids E and I sampling had total pesticide concentrations of 7.24 mg/kg and 5.915 mg/kg. All other sampling locations were below the 5 mg/kg RAO.

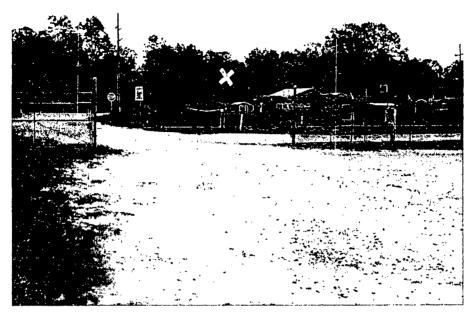
Picture 10-1 Gated Entrance to the Helena Chemical Site

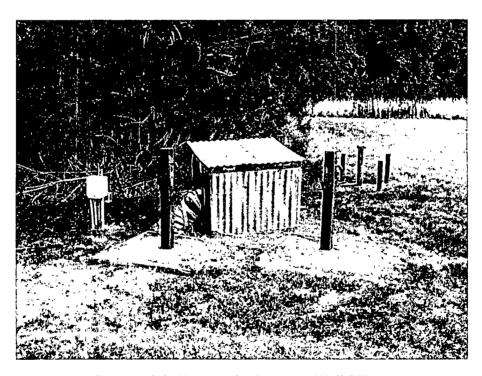
Picture 10-2 Housing for Recovery Well RW-1

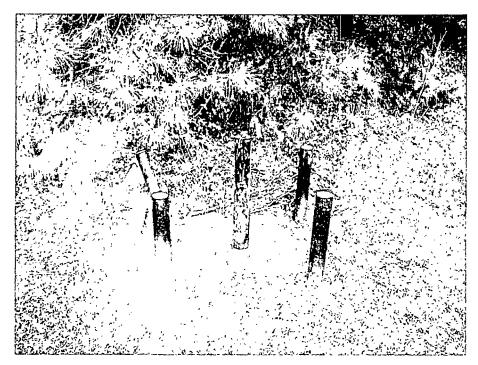
Picture 10-3 Monitoring Well MW-4

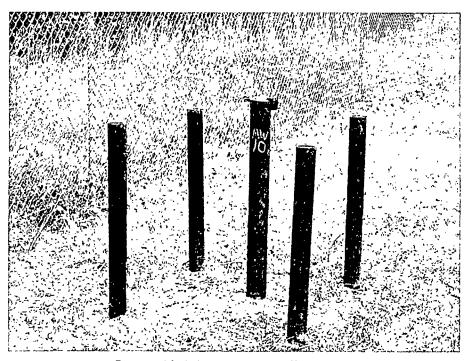
Picture 10-4 Monitoring Well MW-10
